Destroyed: Conventionally built structures

Major: Conventionally built structures

Destroyed: Manufactured home

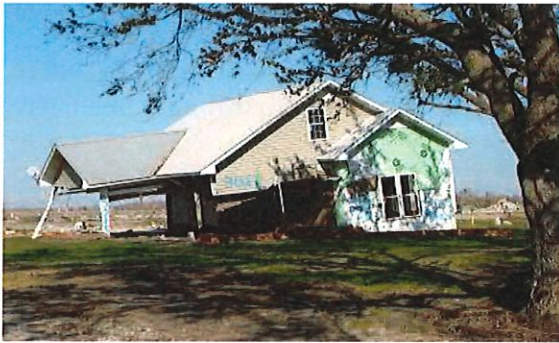
The foundation and two or more walls of this residence have failed.

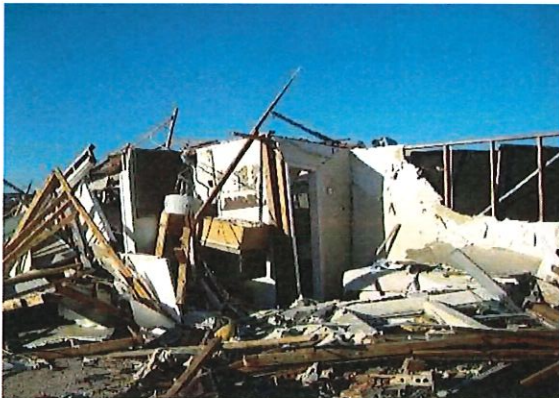
This residence has collapsed.

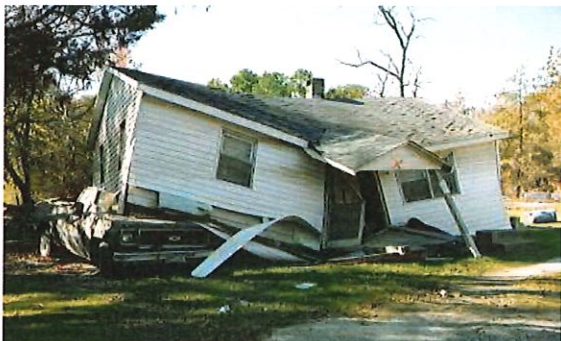
The roof and walls of this home have been compromised and it is off its foundation.

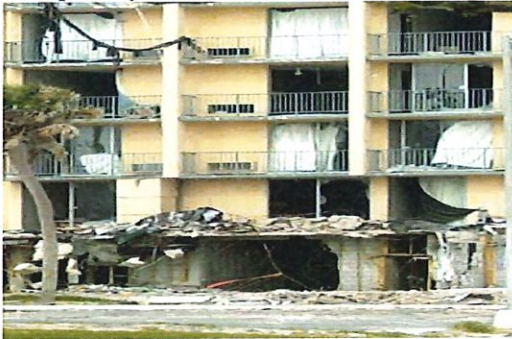
Based on this view, at least 12 units should be classified as having major damage. All units in an apartment building will not necessarily have the same damage level.

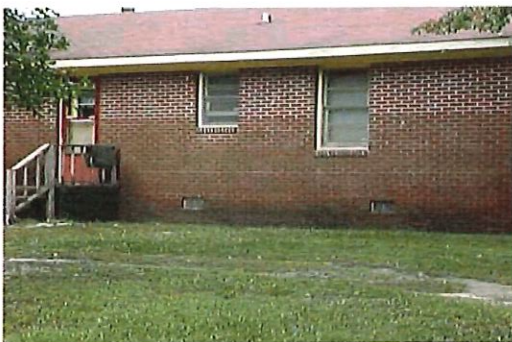
The visible water line on the residence is higher than 18 inches on the first floor.

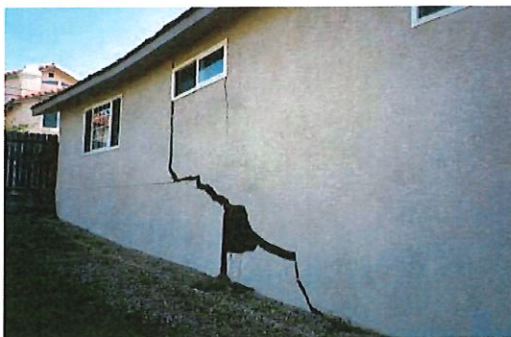
The structural elements of this wall have failed.

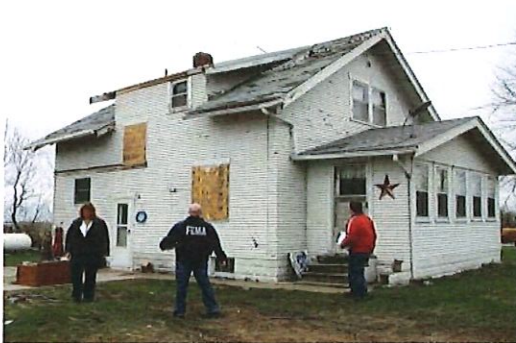
This residence has nonstructural damage to the roof and broken windows.

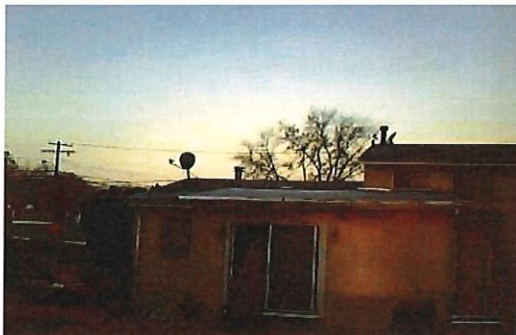
The roof on this residence has been tarp covered after it lost some shingles.

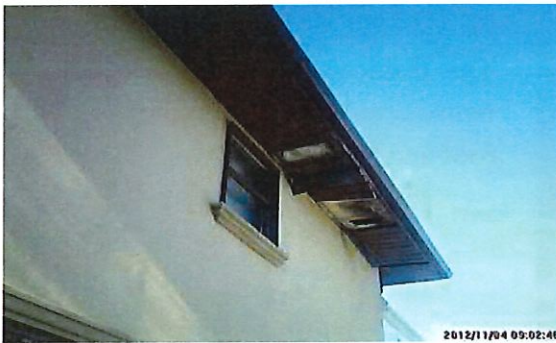
Damage to this soffit represents nonstructural damage to the roof.

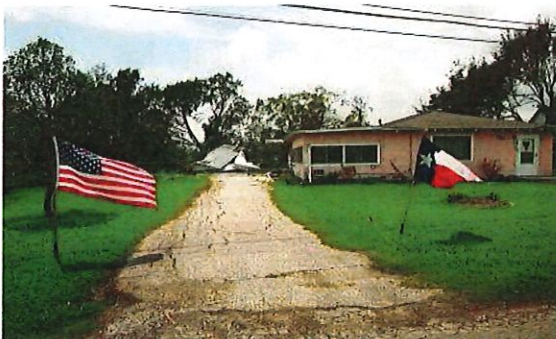
Only an outbuilding has sustained damage.

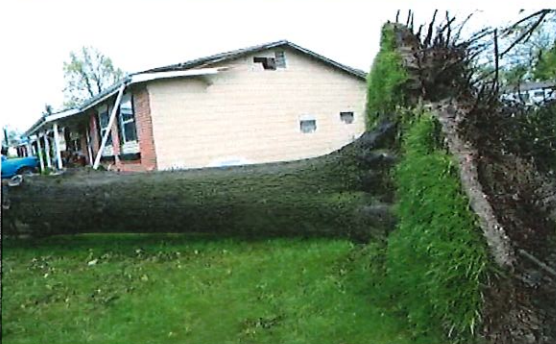
The residence has gutter and roof damage. The tree does not impact the damage level of the home.

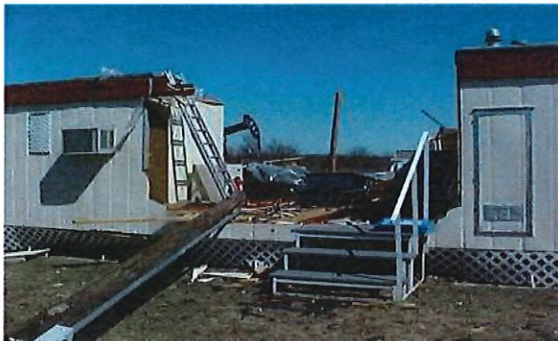
The manufactured home is missing the roof and at least two walls.

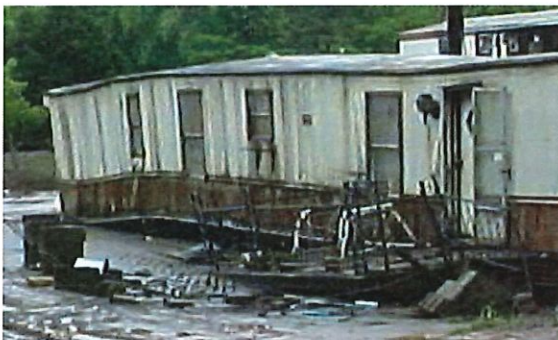
The frame of the manufactured home has been bent.

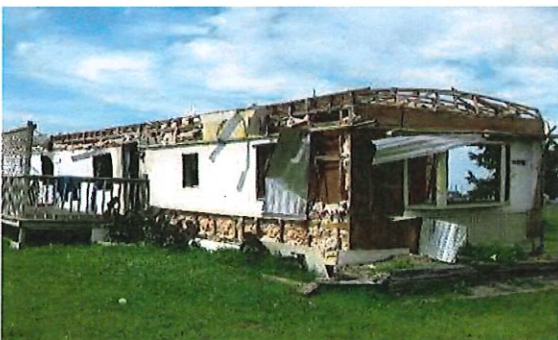
This manufactured home is missing the roof covering, and at least one wall has been compromised.

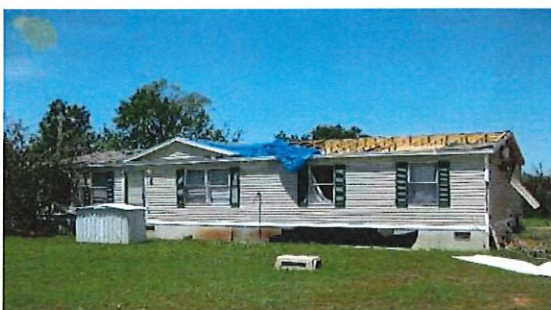
Although much of the roof is missing, the structural ribbing of the roof system is still intact.

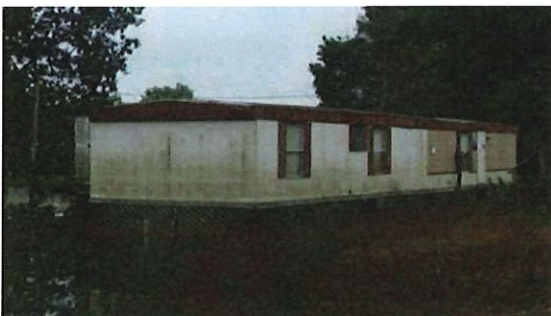
Visible water line above the floor system.

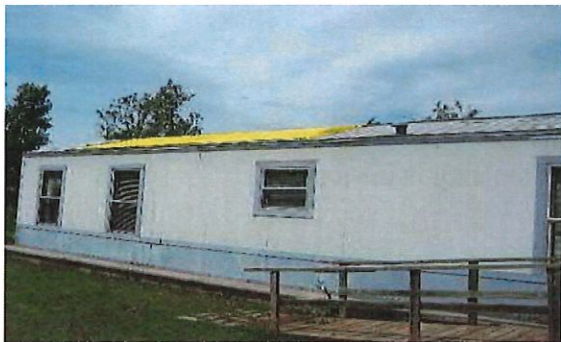
A portion of the roof has been damaged.

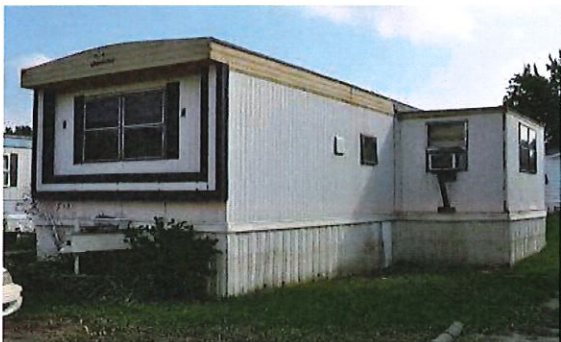
The visible water line is below the floor system.

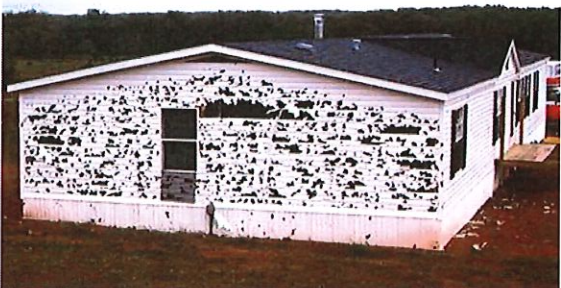
Nonstructural components of one wall have sustained damage.

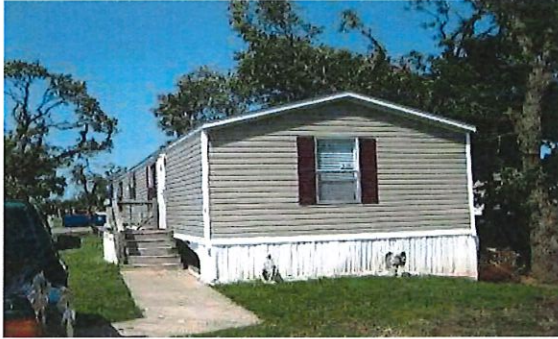
The only damage missing the skirting.

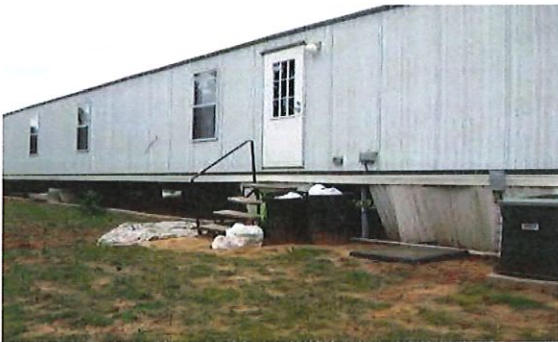
There is no visible water line and only skirting is missing or bent.
